**Flood Control Project Maintenance
Levee Inspections**

Maintenance Issue Types Only, Levee Inspection Report By Mile - Fall 2018

Sutter Maintenance Yard Murphy Slough at M&T Ranch

Waterway	Bank	Unit Miles	Inspection Start/End	Inspector
Unit No. 01 Murphy Slough at M&T Ranch	Left	0.83	10/24/2018 10/24/2018	Bob Duffey

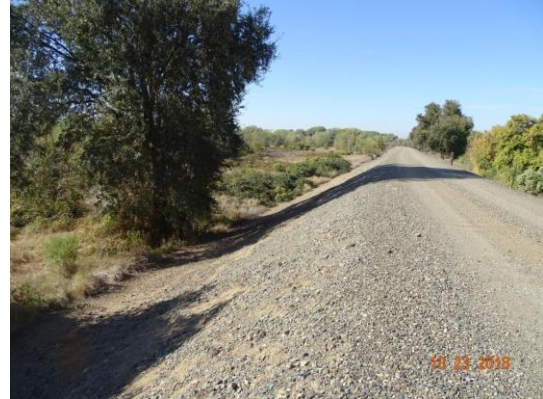
Photo 1 of 1 : FA_2018_ST0014_372_5_20181102_00004.jpg

LM Start	0.10	Rating **	A	Issue No.	5
LM End	0.83	Issue Type +	Ma	Location *	LS
Category	Earthen Levee			GPS Latitude/Longitude	
				Start	End
Item	Vegetation			39.666877°	39.670703°
				-121.960768°	-121.970448°
DWR ID	DWR_ST0014_01_f_2018_5				
Comment Code					
V1 : Control annual grass and weeds on the levee slopes and easements.					
Inspector Comment					
The vegetation has been removed from the landside slope.

View of no vegetation on the landside slope.
